KSC Engineering Directorate
Materials Science Division

Space Spalls

STS-120 International Space Station (ISS) Starboard Solar Alpha
Rotary Joint (SARJ) Debris Analysis

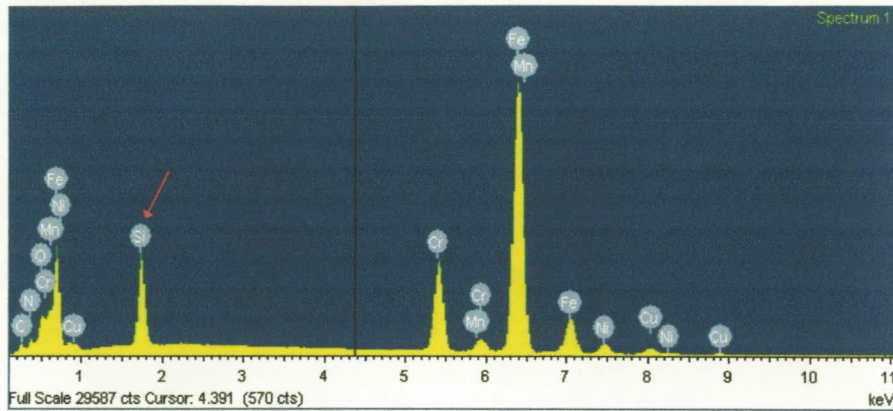
Representative spectrum from debris – corresponds most closely to nitrided 15-5 PH. The silicon peak is due to the silicone adhesive on the Kapton tape.

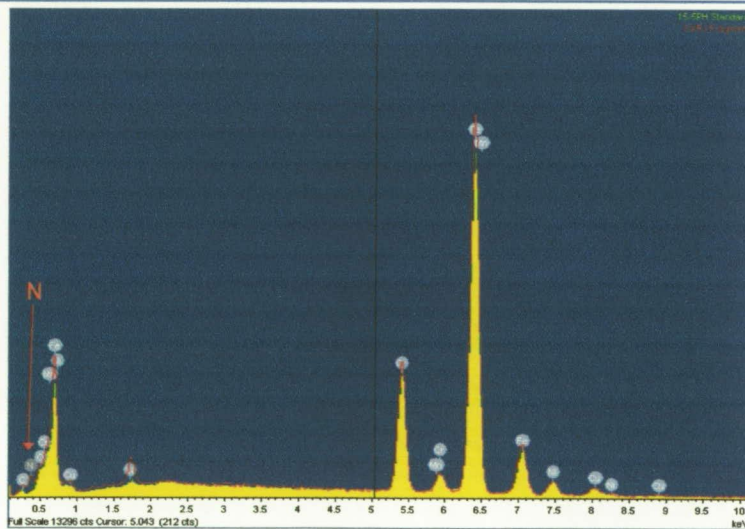
Overlay of representative spectrum from debris (red) on the baseline 15-5 PH spectrum. N peak indicates that the debris is from the nitrided layer.

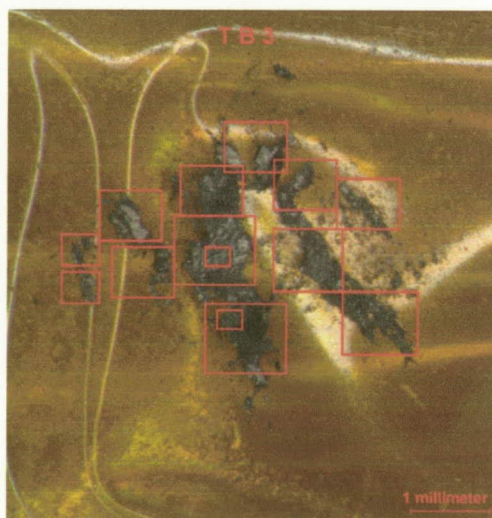
Chemical Analysis of Third Back Sample

All 15-5 PH with Nitrogen
No trace elements

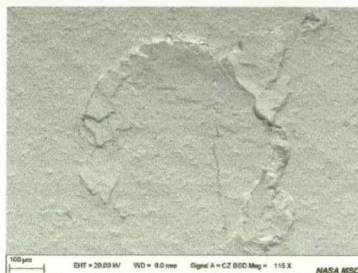
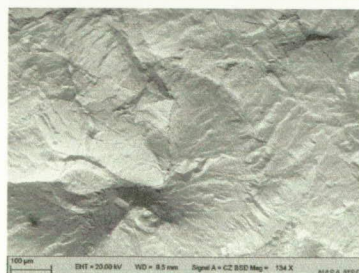
SEM Images of Large Particle from Short Front Sample

Nitrided 15-5 PH surface with machine markings on obverse (L) and flipped over revealing scalloped reverse (R).

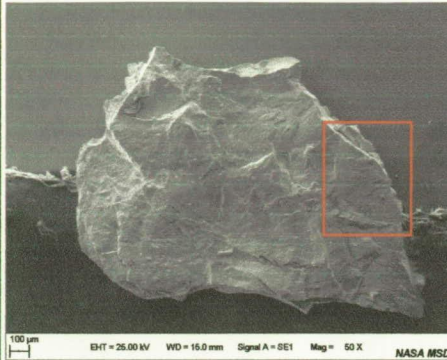
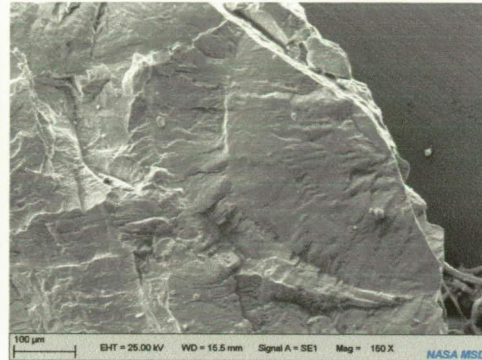
SEM image of fragment removed from tape imaged under high vacuum in secondary electron (SE) mode. Area in red box appears to be a fracture initiation site and fan-shaped region within the box suggests crack arresting.

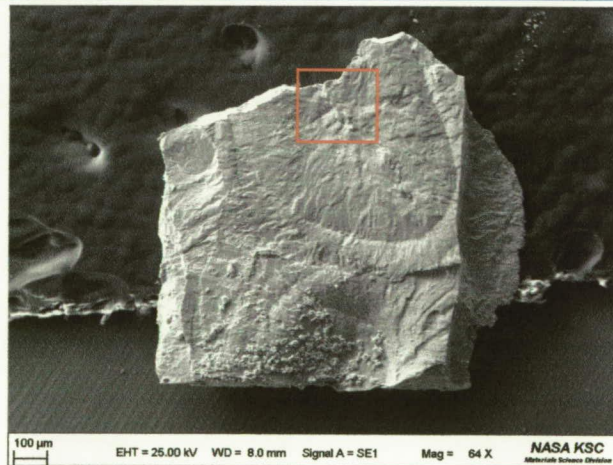
SEM image of fragment removed from tape and imaged under high vacuum in secondary electron (SE) mode. Area in red box appears to be a fracture initiation site and elliptical region suggests crack arresting. Features typical of spalled fragments.

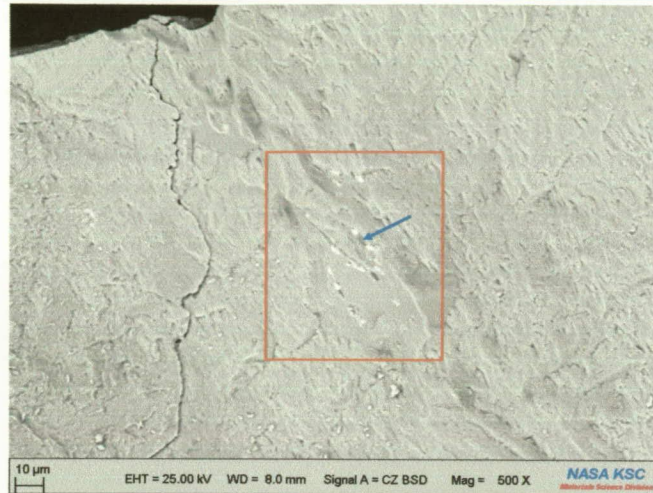
Backscattered Electron Image of an Initiation Site

Backscattered electron image of outlined area in red box from slide 21 showing atomic contrast. The white constituent in the box is primarily niobium (Nb), and the black constituent next to the blue arrow is MnS, as confirmed by EDS.

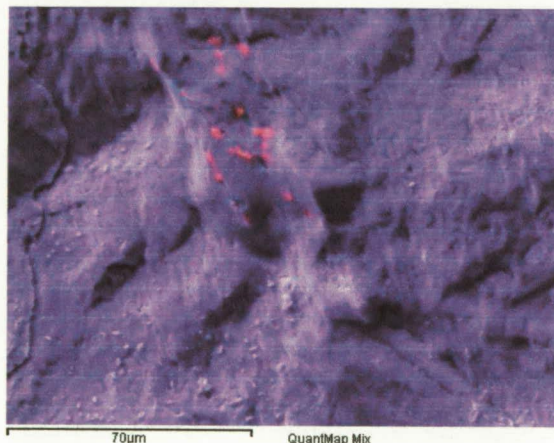
X-Ray Elemental Dot Map at Initiation Site

X-ray elemental dot map of same apparent initiation site outlined in slide 21, showing Nb-rich precipitates in an Fe-rich matrix. Note: Mn and S pixels are masked in this image.

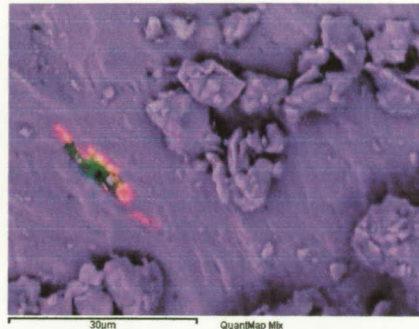
X-Ray Elemental Dot Map

X-ray elemental dot map showing Nb-rich precipitates in an Fe-rich matrix and a MnS inclusion. MnS inclusions were often located in the vicinity of the Nb-rich precipitates.

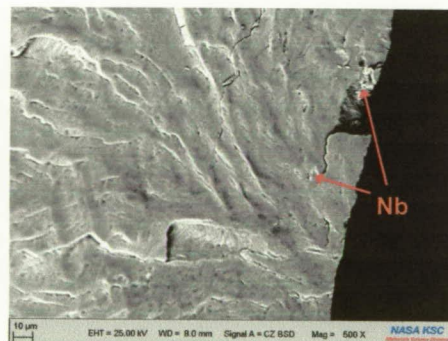
Additional Fracture Initiation Sites with Nb-Rich Precipitates

Backscattered electron image showing atomic contrast of the Nb-rich precipitates at a typical subsurface fracture initiation site.

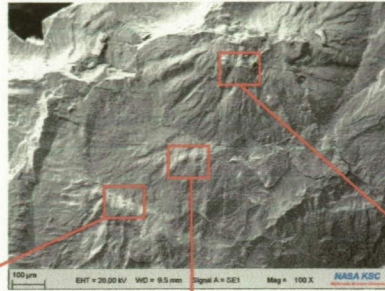
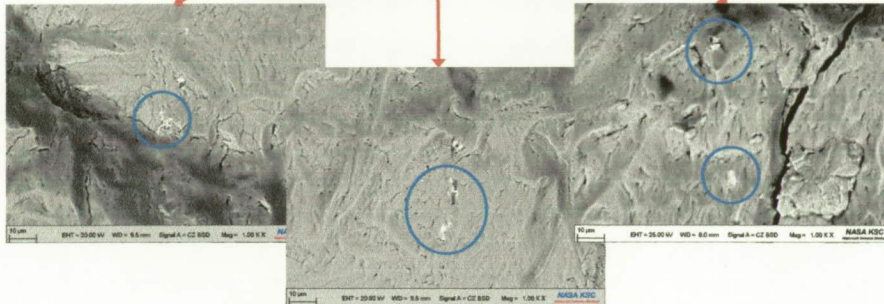
Additional Fracture Initiation Sites with Nb-Rich Precipitates

Backscattered electron image showing atomic contrast of the Nb-rich precipitates at typical subsurface fracture initiation sites.

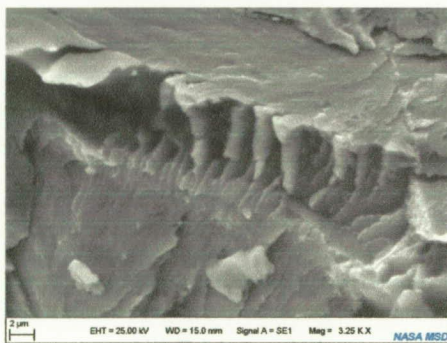
Side of fragment

Cleavage steps

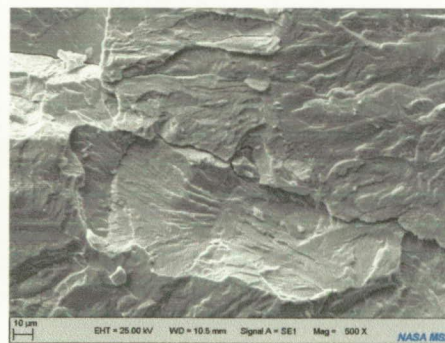
Reverse face of fragment

Cleavage feather pattern

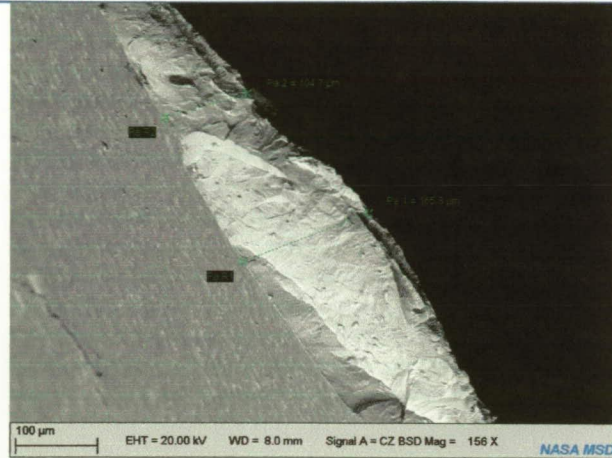
Particle thickness measurements of large particle in the SEM correlated with measurements taken using laser confocal microscopy, which were 100 to 165 μm for this particle.

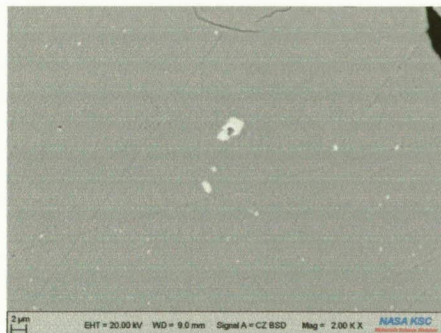
Backscattered electron image showing atomic contrast of typical Nb-rich precipitates (white) and MnS inclusions (black) in the 15-5 PH matrix (gray). The geometry and length scale of the SARJ fragment precipitates were comparable with those of stock 15-5 PH. The hardness of the stock 15-5 PH indicated that it has a similar heat treatment as the SARJ specification.

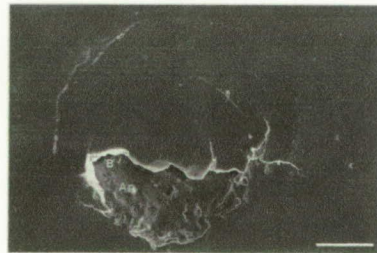
- Contact stress fatigue, i.e. spalling, with subsurface initiation
 - Location of origin – “Short distance below surface, usually at a nonmetallic inclusion”
 - Initial size – “Small”
 - Initial shape – “Irregular”
 - Crack angle with respect to surface – “Roughly parallel at bottom, perpendicular at sides”
 - Apparent occurrence – “Sudden”
